VIBRATION SURVEY OF BLADES IN 19XB AXIAL-FLOW COMPRESSOR

II - DYNAMIC INVESTIGATION

By André J. Meyer, Jr. and Howard F. Calvert

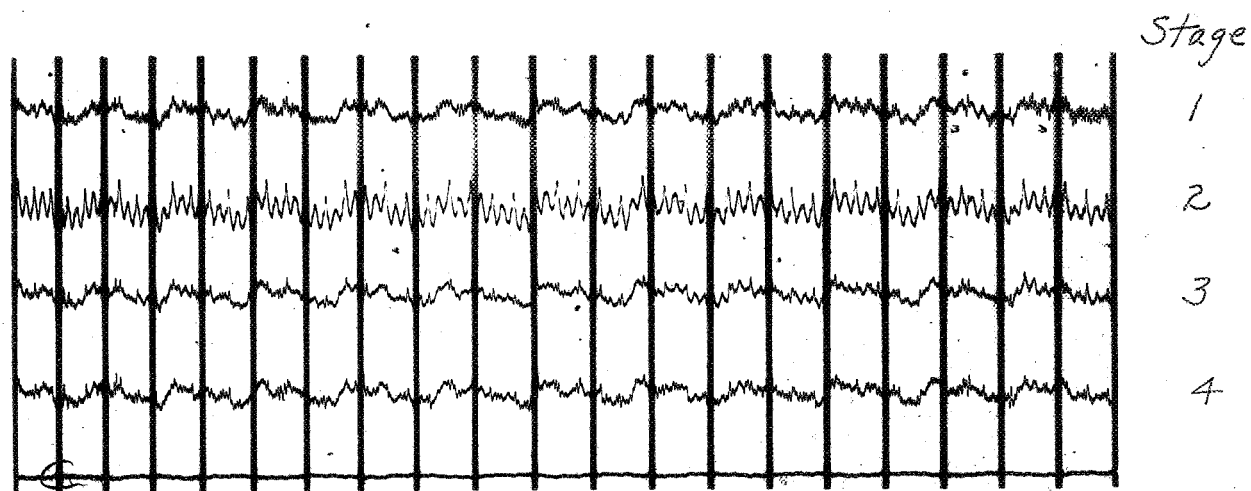
Figure 10. - Effect of varying pressure ratio at rotor speed of 8190 rpm.

The effect of changing pressure ratio of the compressor by throttling the exhaust is clearly shown in figure 10. All gage signals were taken at the same amplification and rotative speed (8190 rpm) at pressure ratios of 1.17 and 1.54. The rotor speed was so set that the signal from stage 2 would be in fourth-order resonance at a pressure ratio of 1.17. The vibration amplitude of the second-stage signal was more than doubled by the pressure-ratio increase; the third- and fourth-stage blades vibrated at 4.65 and 4.72 orders, respectively, at a pressure ratio of 1.54 and did not vibrate at the low pressure ratio. Furthermore, no correlation was apparent between time and the high and the low amplitudes of the second-, third-, and fourth-stage signals at a pressure ratio of 1.54. These effects of change in pressure ratio were investigated at several other rotative speeds and the same results observed. All stress measurements were comparatively low but the limited driving power did not permit operation at the rated conditions (rotor speed, 17,000 rpm and pressure ratio, 4.0).
